# Type 1 Facility Closeout Report

<b>Section A. Facility Data</b>	
Facility No	Building 116
Facility Descriptor	Office Building
Project	Area 5 Group 1 Closure Project
Date of Demolition:	October 20, 2003 through December 3, 2003
Additional Information	See Attached
<i>(Must include information on environmental releases and conditions of site at turnover to Environmental Restoration)</i>

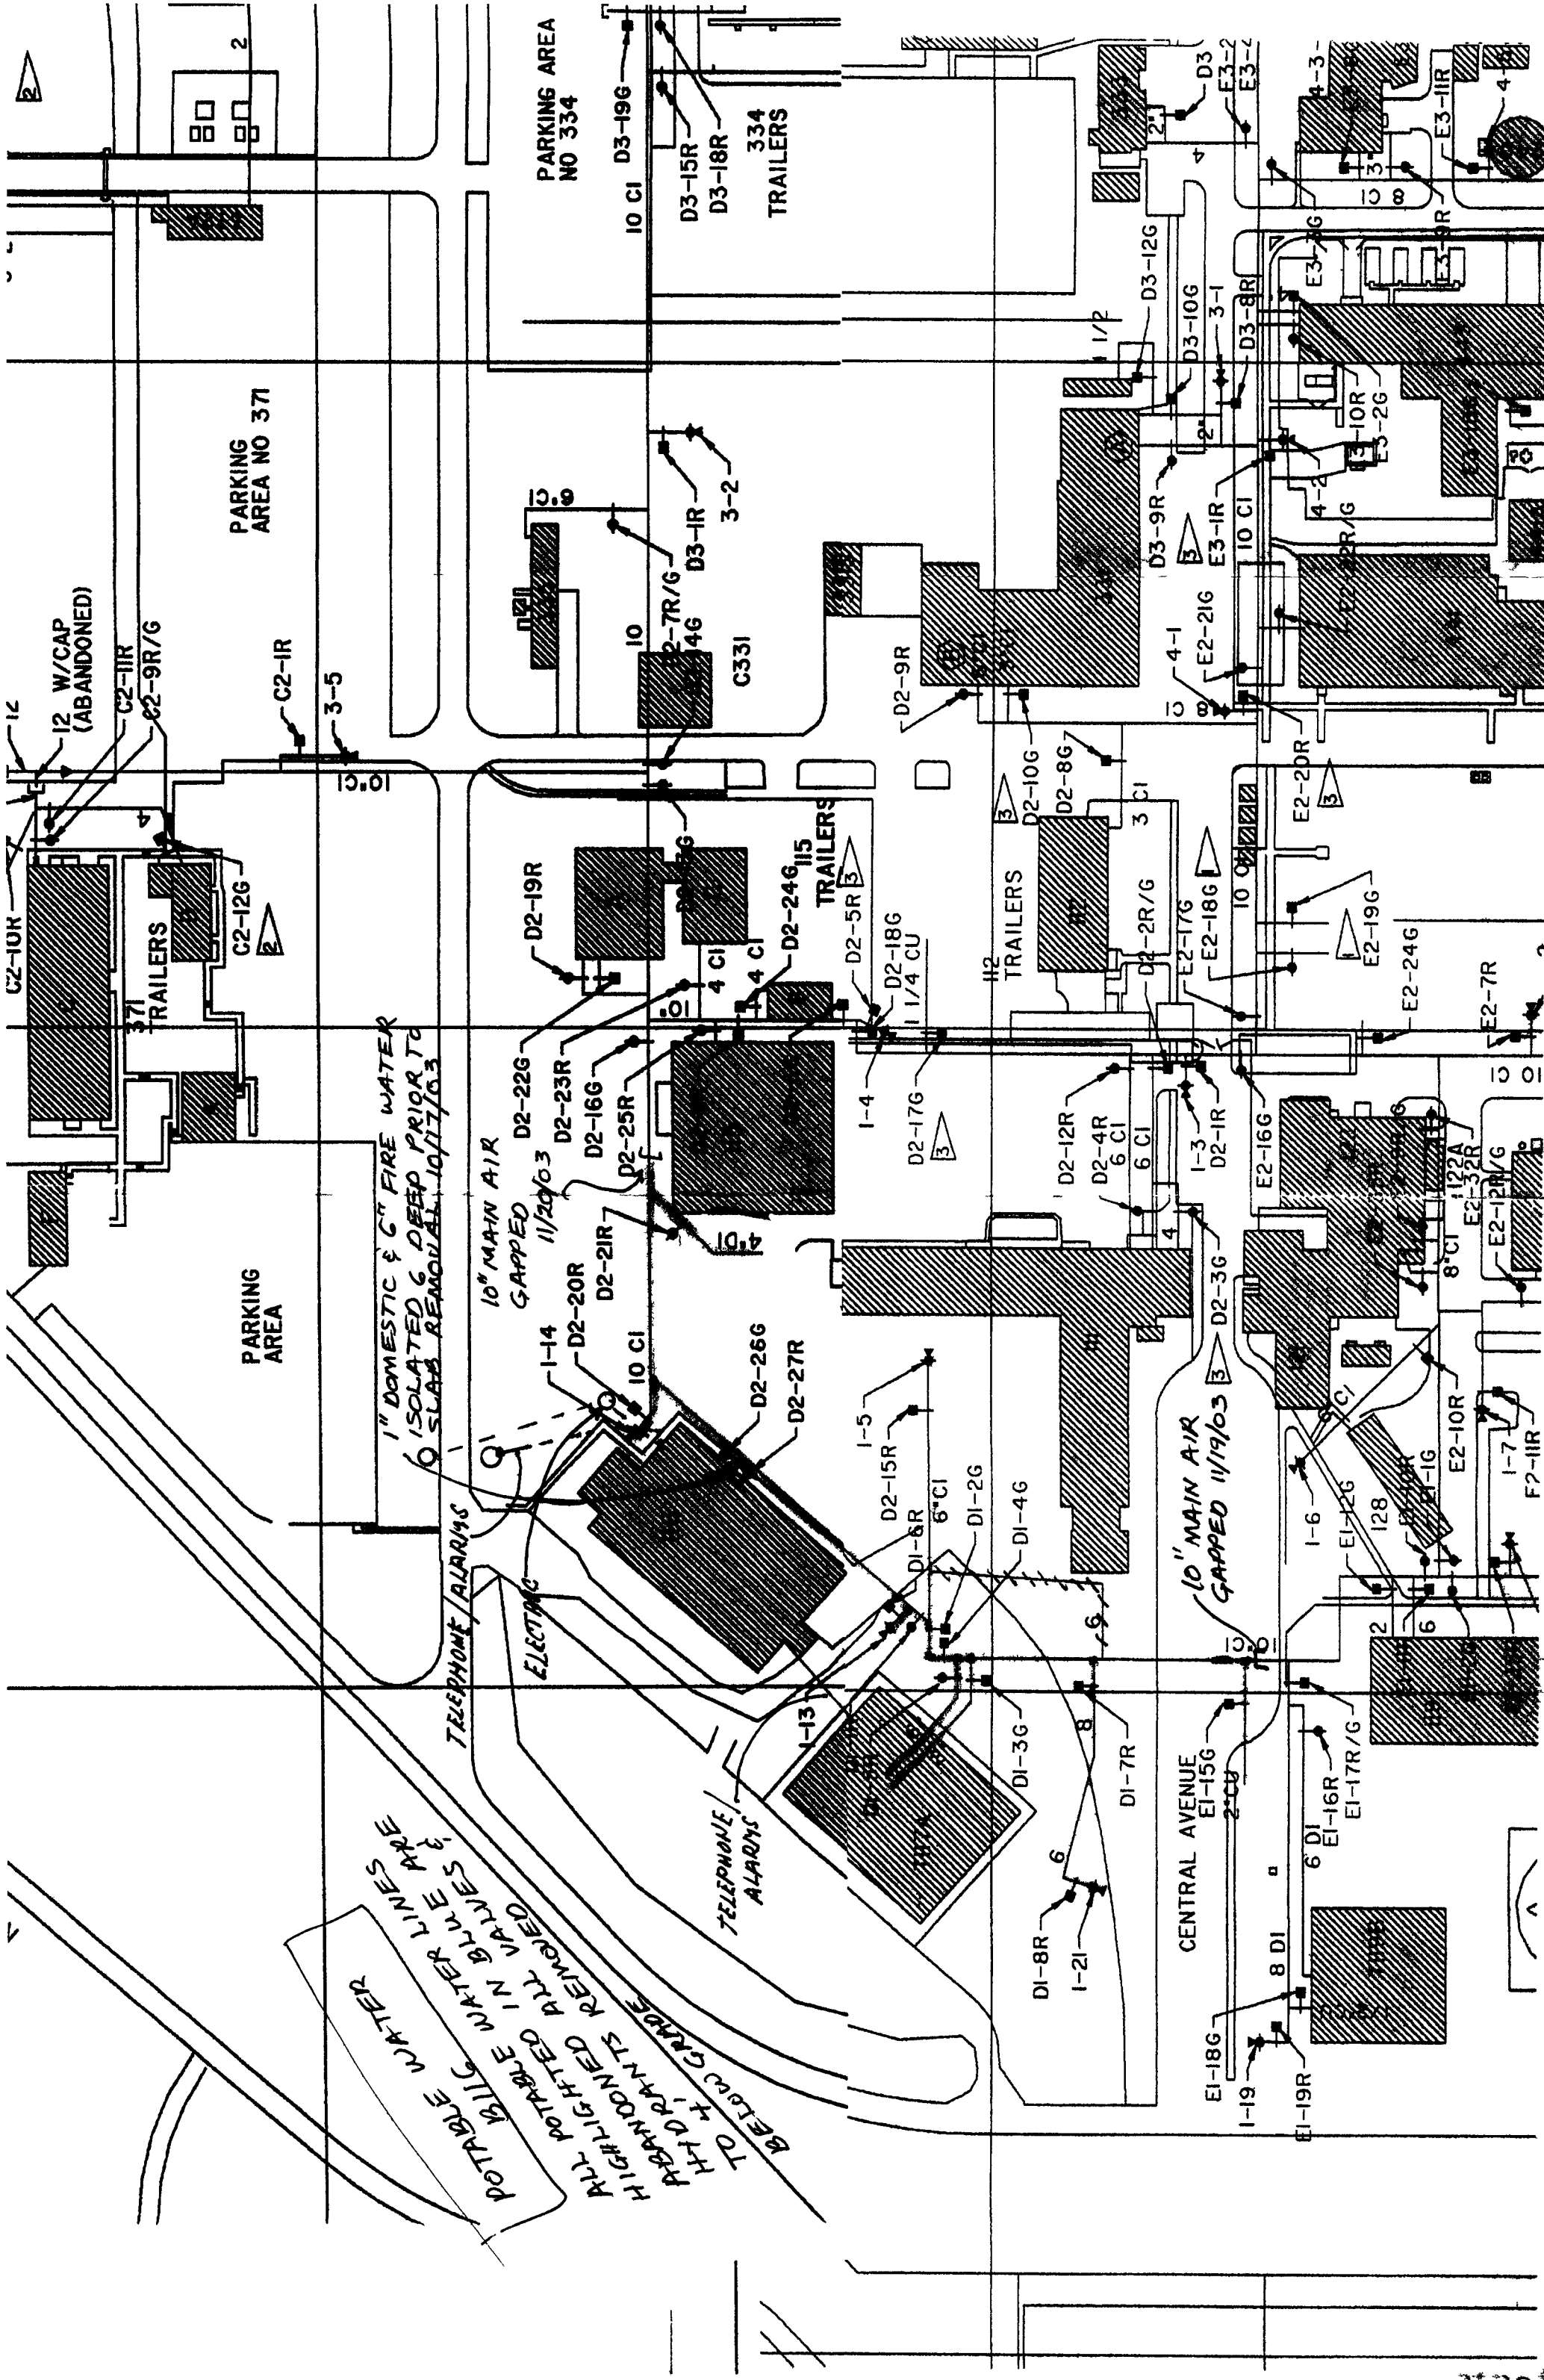
POTABLE WATER  
ALL POTABLE WATER LINES  
HIGHLIGHTED IN BLUE ARE  
ABANDONED ALL VALVES &  
HYDRANTS REMOVED  
TO 4' GRADE  
BELOW GRADE

1" DOMESTIC & 6" FIRE WATER  
ISOLATED & DEEP PRIOR TO  
SLAB REMOVAL 10/17/03

10" MAIN AIR  
GAPPED 11/19/03

10" MAIN AIR  
GAPPED 11/20/03
